Flexural behaviour of BFRP rebar reinforced concrete beams

The Plymouth Student Scientist

Project Advisor: [Dave Easterbrook](#), Plymouth University, Drake Circus, Plymouth, PL4 8AA

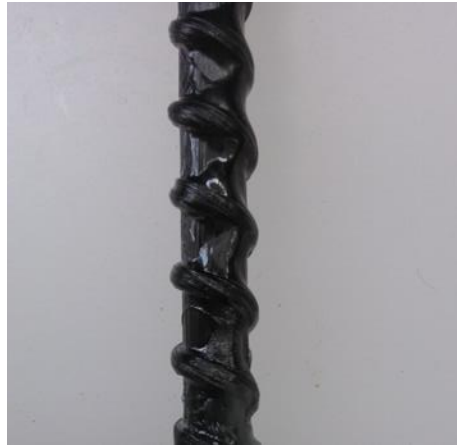
Basalt is a naturally occurring volcanic rock that originates from frozen lava that can be found in abundance in the Earth's crust. Basalt Fibre Reinforced Polymer (BFRP) rebar is formed by crushing basalt rock into a powder which is then heated to melting point (approximately 1450 degrees Celsius). A fine nozzle is then used to extrude the molten material to form a thin continuous strand. These strands are bundled and bound together by using a polymeric compound, to produce long straight rebars. Often supplementary BFRP strands are used to form spiral ribbing, by winding them transversely around the rebar, to provide containment and rigidity to the rebar and increase the strength of the mechanical anchorage between the concrete and rebar (Gohnert, Gool & Benjamin, 2014). Figure 1 demonstrates the finished product of BFRP rebar.

Figure 1: Basalt Fibre Reinforced Polymer rebar.

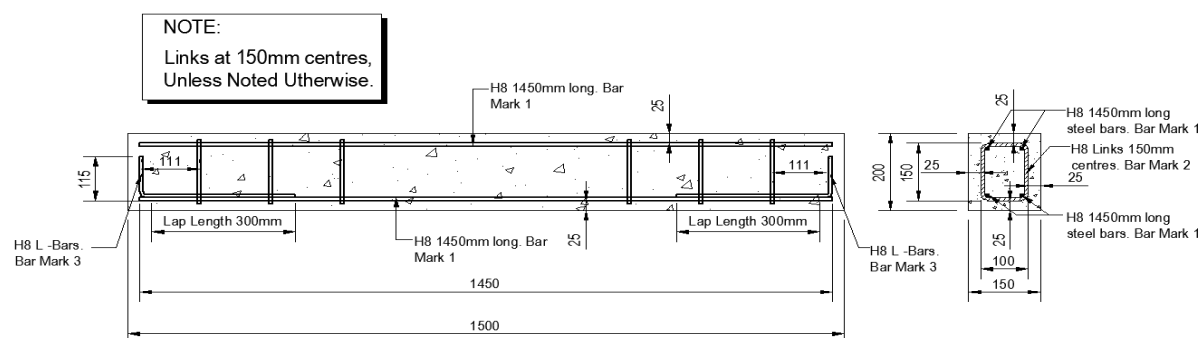
Four reinforced concrete beams (150mm wide, 200mm deep and 1500mm long), containing different reinforcing setups as indicated in Figure 2 were used. Due to constraints in the laboratory, the reinforcement cover was reduced to be 25mm. The diameter of the BFRP and steel rebar element sizes that were used in this experimental study are both 8mm. The information regarding the reinforcement setting-out, sizes and element length are outlined in Figure 2 and in the bar bending schedule

Figure 2: Reinforcement Setting-Out.3

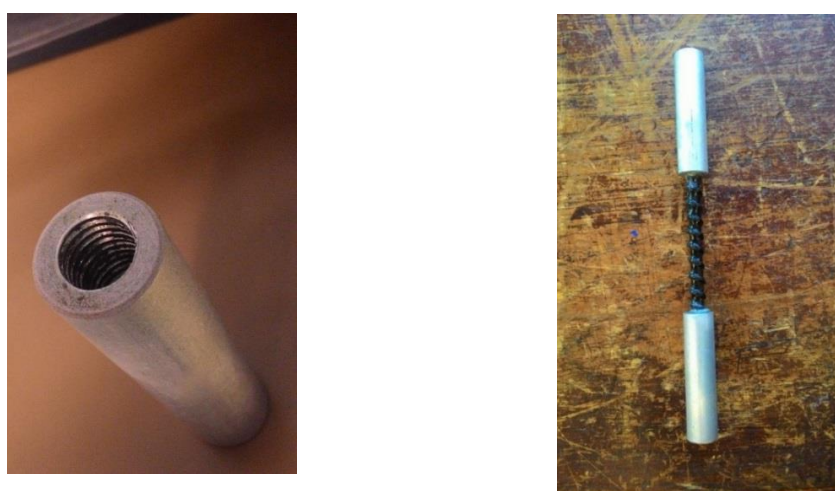
Both ends of the BFRP rebar sample were encased in the aluminium rods that were threaded inside, as illustrated in Photo 1.

Photo 1: BFRP rebar encased in threaded aluminium rods.

During the second attempt to increase the surface grip area, two aluminium rods were attached to each end of the basalt rebar sample. Holes with a 10mm diameter were drilled and the inside faces of the walls of the aluminium rods were threaded to increase the mechanical key between the BFRP rebar and the aluminium rod. Subsequently each end of the basalt rebar sample was placed inside the aluminium rods and set with resin and adhesive. During the tensile testing stage the basalt rebar pulled out of the aluminium rods before it reached its maximum tensile capacity. It was concluded that failure occurred due to the resin shear resistance being significantly smaller than the tension force applied by the testing machine (refer to **Error! Reference source not found.** in appendix **Error! Reference source not found.**). Gohnert, Gool & Benjamin (2014) claimed that by encasing both ends in tight fitting tubes, the maximum tensile capacity of BFRP rebar was achieved. Therefore, it is arguable that Gohnert, Gool & Benjamin (2014) in his study used specifically high shear resistance resin when undertaking tensile tests. In addition to that, when visually inspecting aluminium rods it was observed that they did not deform. Thus, this suggest that the aluminium rod wall could be too thick and therefore did not transfer the “grip” to the BFRP rebar (refer to **Photo 1**).

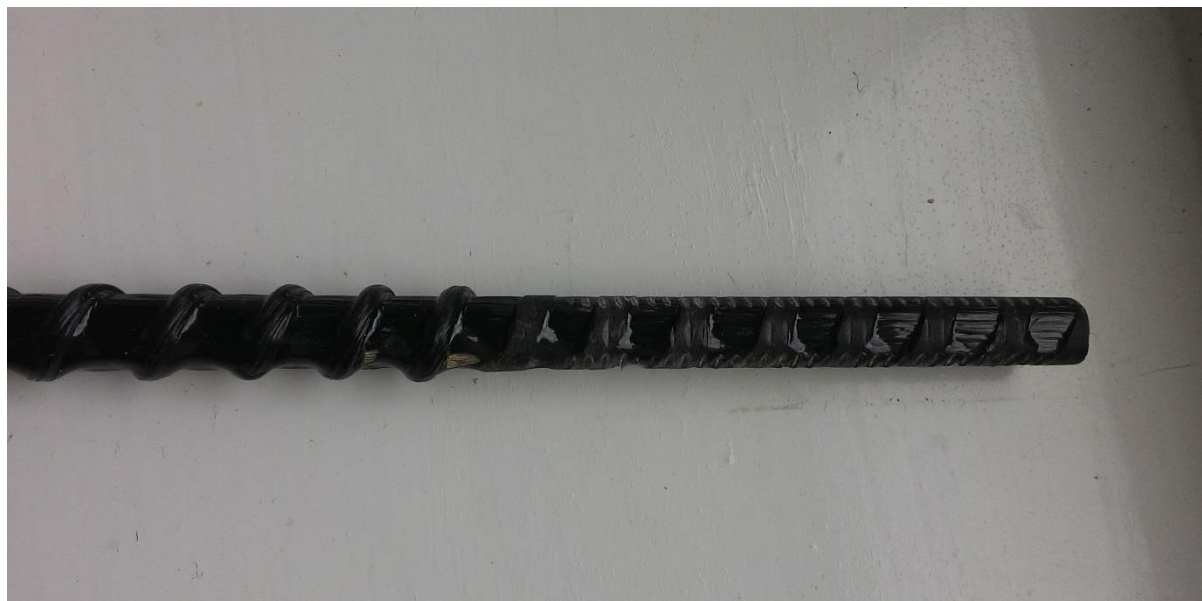
Both ends of the BFRP rebar sample had 50mm of the BFRP spiral sanded off the overall length (refer to Photo 2).

Photo 2:Ends of BFRP Rebar Sanded Off.

Moreover, it was attempted to “sand off” the BFRP spiral at each end as illustrated in **Photo 2**. Once again the experiment failed to test BFRP rebar maximum tensile capacity as one end of the rebar came out of the testing machine clamps. During the visual inspection, it was observed that the “teeth” of the upper clamp were partly damaged. **Error! Reference source not found.** attached in appendix **Error! Reference source not found.** illustrates the damaged “teeth” condition. Additionally, when the smaller size clamps were used, the failure of the test was caused by the BFRP rebar sample crushing inside the clamps (refer to **Error! Reference source not found.** attached in appendix **Error! Reference source not found.**). Due to brittle nature of fibre binding resin, it was not able to withstand the force in the lateral direction.

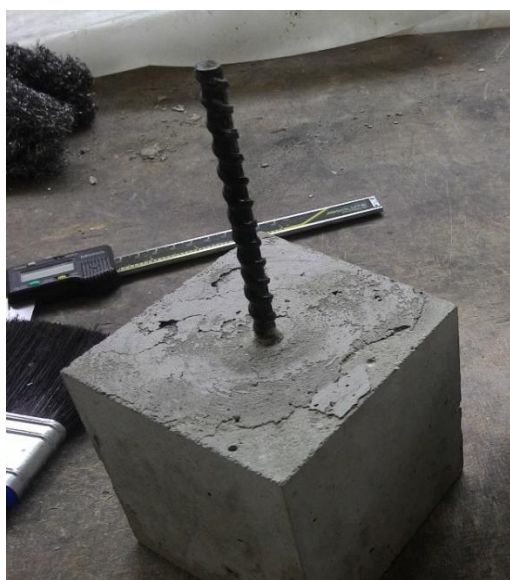
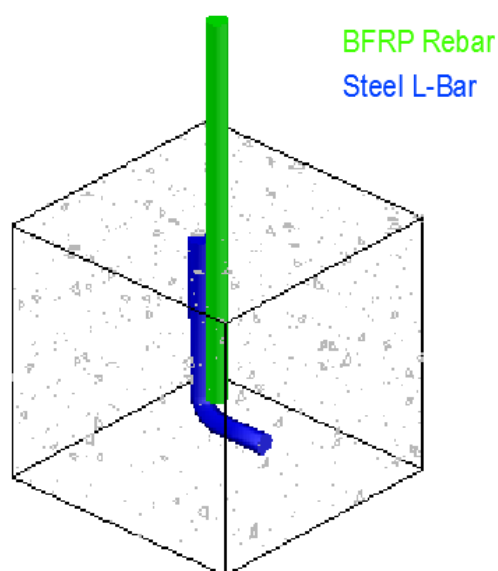
The BFRP rebar lapped with steel L bar and encased in class40/50concrete cube (100 mm x 100 mm x 100 mm). A concrete cube mix was designed to ensure that compression failure does not occur before BFRP rebar tensile capacity is reached. Refer to appendix **Error! Reference source not found.** for the concrete mix design.

Photo 3:BFRP Rebar Encased Concrete Cube.

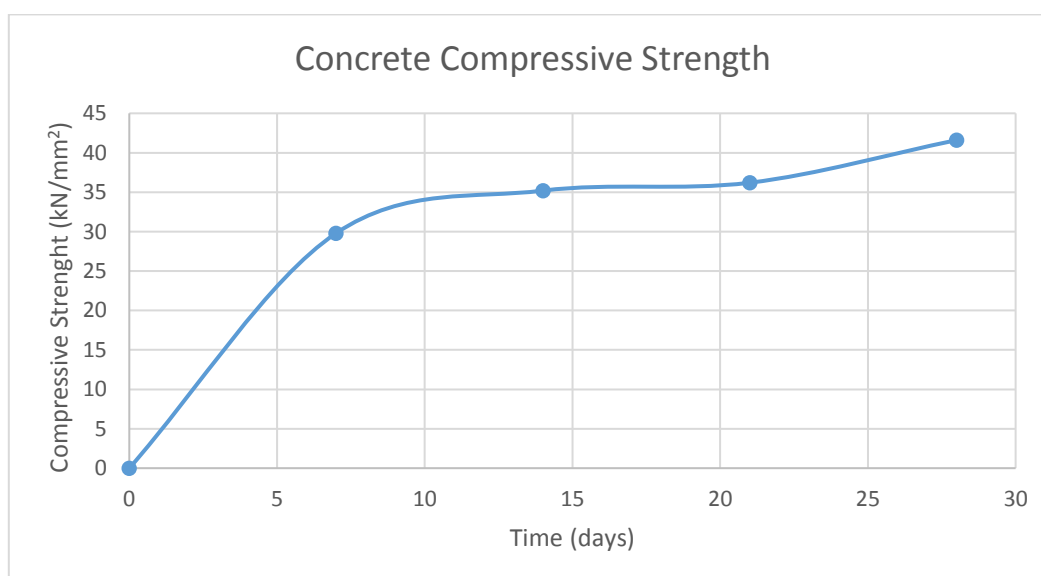
Appropriate personal protective equipment (PPE) was used including protective goggles, rubber gloves, a dusk mask and a laboratory coat. Further to that, based on the manufacturer’s COSHH assessment form, no additional PPE has been required during handling of the BFRP rebar. The COSHH assessment form regarding the BFRP rebar is attached to the appendix **Error! Reference source not found.**. Multiple cube samples were cast during the reinforced concrete beams casting stages to determine compressive strength of the beam when tested. Cubes were placed in the water chamber for controlled curing purposes (refer to appendix **Error! Reference source not found.**). Additionally, the progression of compressive strength was closely monitored and the concrete cubes were tested at 7, 14, 21 and 28-day periods. Further to that, compression tests were carried out on the same day each reinforced concrete beam was tested. Graph 1 depicts the compressive strength progression of class C28/35 concrete.

Graph 1: Concrete Compressive Strength Progression.

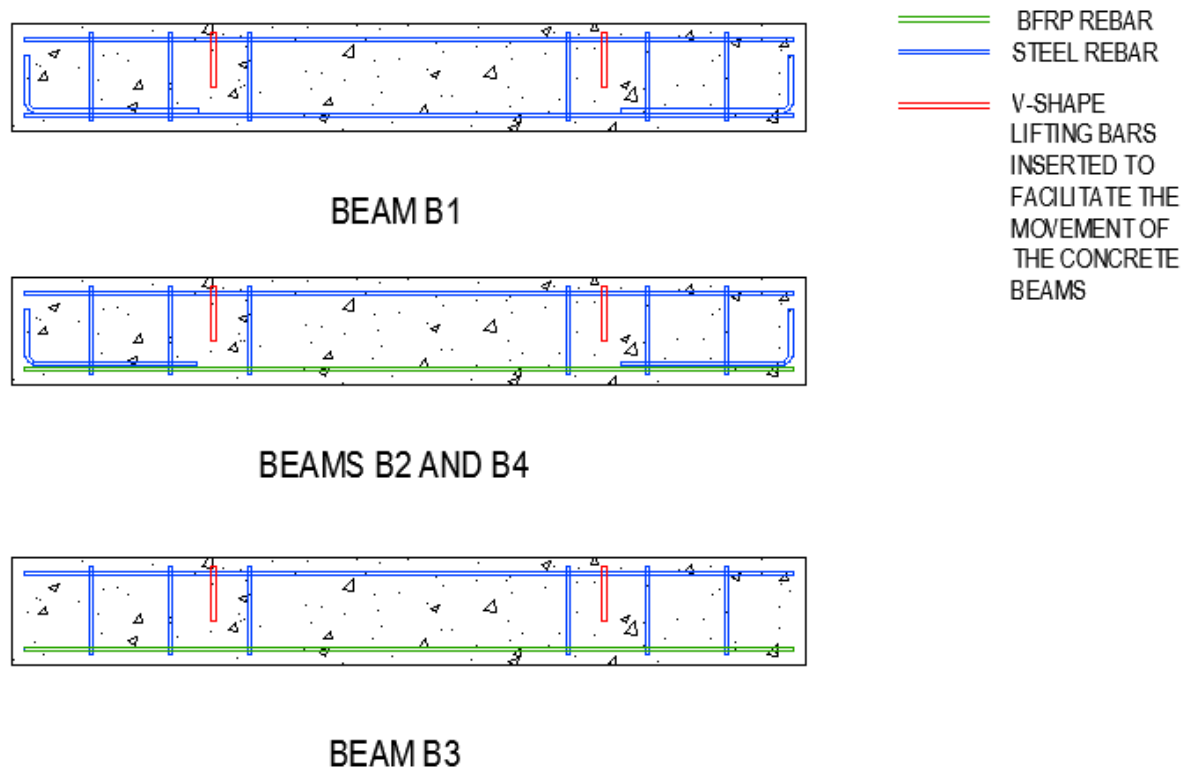
Research into existing BFRP Rebar manufacturers determined that the manufacturer “Vulkan” based in Denmark would sponsor the project by supplying the required BFRP rebar. Four reinforcing cages were assembled with the following features: Cage 1 consisted entirely of steel elements such as top and bottom longitudinal bars, shear links (omitted in the middle region) and L bars. Cages 2 and 4 contained the same steel elements except for the bottom (tension zone) reinforcement, which was substituted with the BFRP rebar. Cage 3 contained the same elements as Cages 2 and 4 except that the L bars were removed. Figure 3 illustrates the different reinforcement setups. Further to that, photos regarding basalt and steel reinforcement setups are attached in appendix **Error! Reference source not found..** Moreover, to facilitate the in-situ casting procedure, appropriate moulds were assembled and all four beams were cast. Photo 4 illustrates the types of moulds that were assembled.

Figure 3: Reinforcement General Layout.

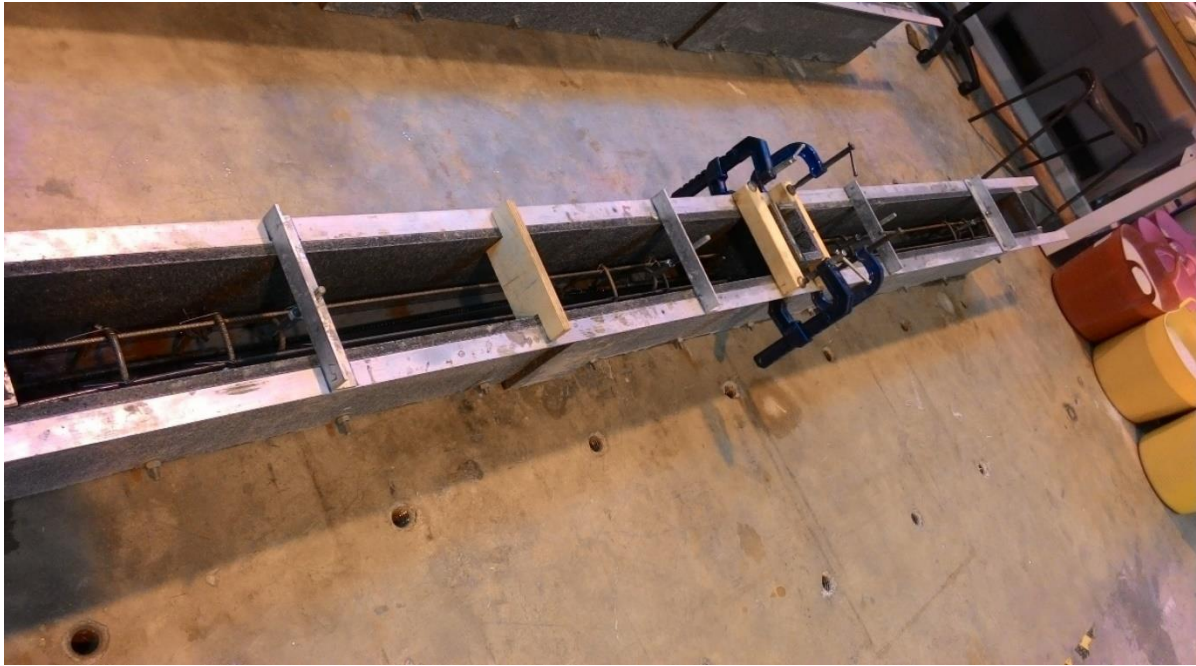
Photo 4: R.C. Beam Mould with Reinforcement Cages Inside.

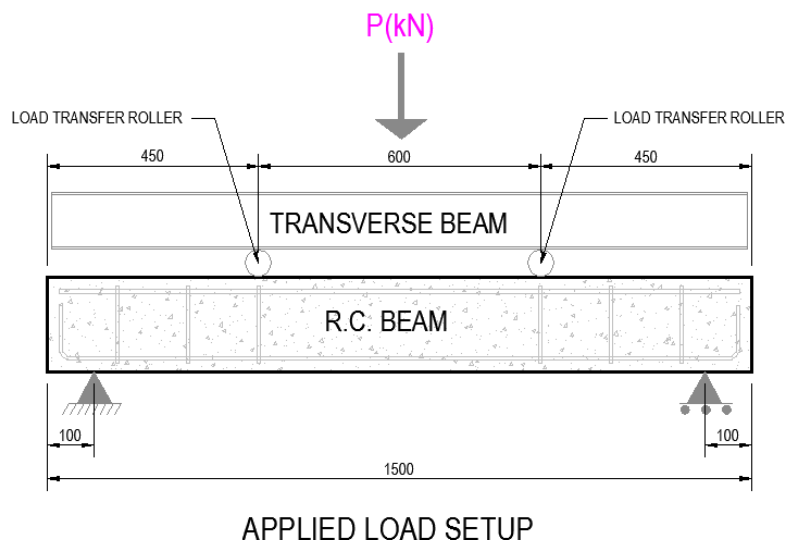
The load was carried by the beams in the four-point system consisting of the steel transverse beam which transfers applied external load to the middle region of the reinforced concrete (R.C.) beam (refer to Figure 4). The transverse steel beam self-weight is approximately 1.3kN which was included in further analysis of the beam test results. To ensure that localized failure at the concrete beam surface due to load transfer rollers did not occur, body filler was applied between the R.C. beam surface and load transfer roller (see **Photo 5**) which acted as a “cushion” during the beam test.

Figure 4: Four Point Load Setup

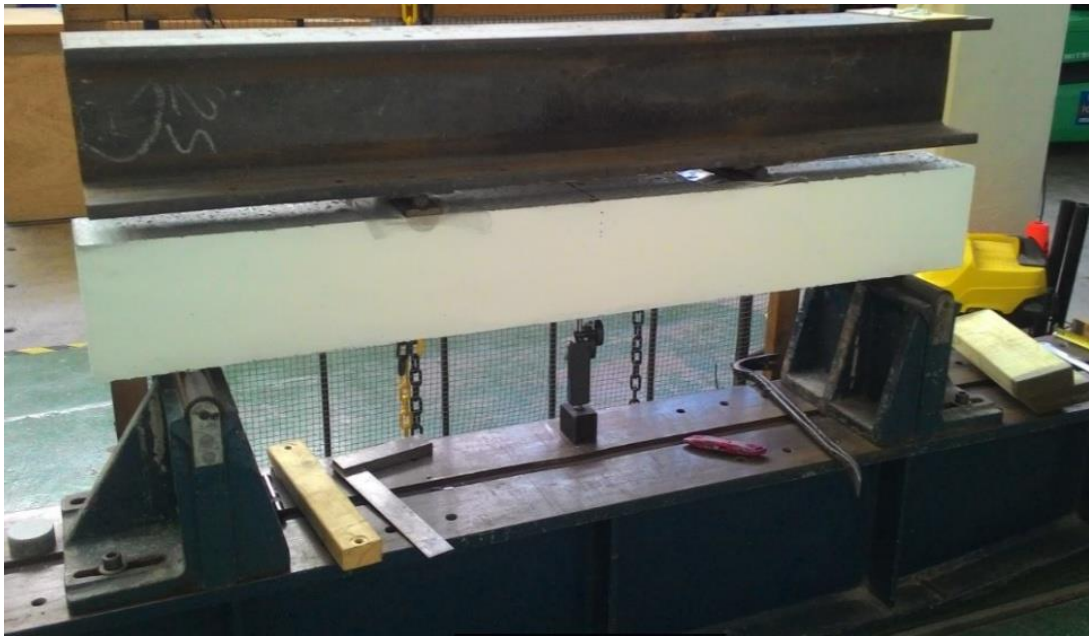
Photo 5:R.C. Beam Two-Point Load Setup.

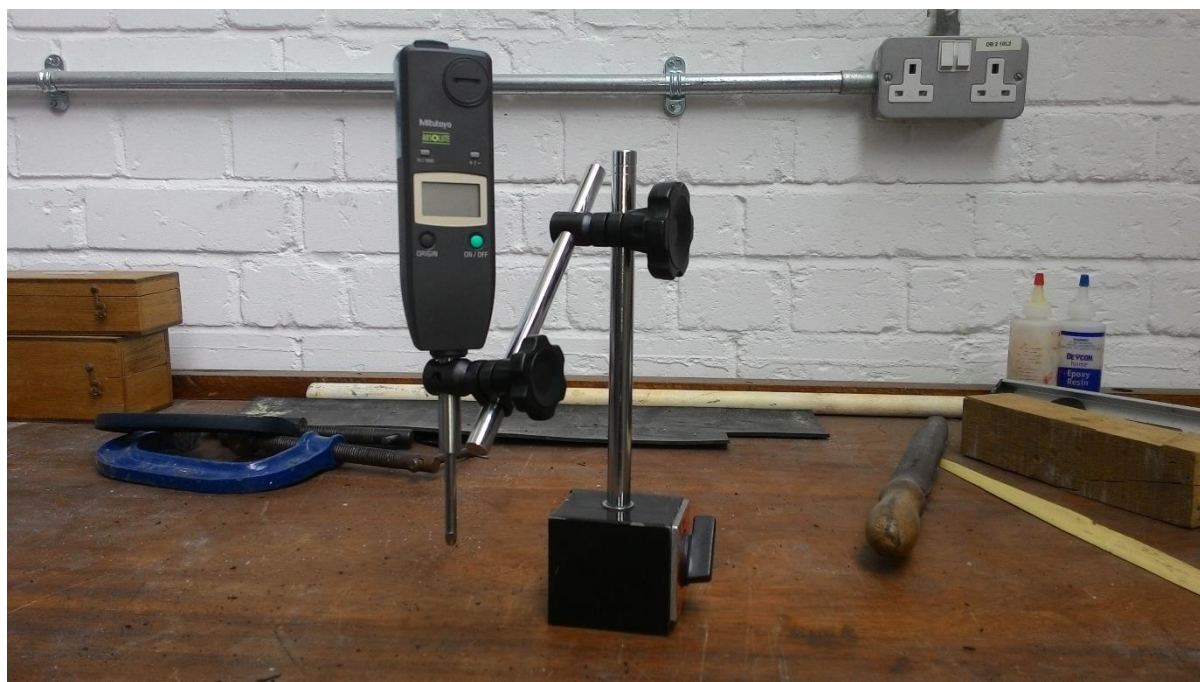
The external vertical displacement gauge was used due to an initial disposition of the experimental load application machinery in the Heavy Structures laboratory. The gauge was applied during the un-cracked section testing phase. The gauge was placed at the mid-span of the under-side of each concrete beam (refer to appendix **Error! Reference source not found.**). During the cracked section testing stage, the external displacement gauge was removed from its original position to prevent the gauge being damaged if brittle concrete beam failure occurred. External deflection readings were used to determine the percentage difference between predicted and experimental deflection of un-cracked section concrete beams.

Photo 6: External Vertical Displacement Gauge.

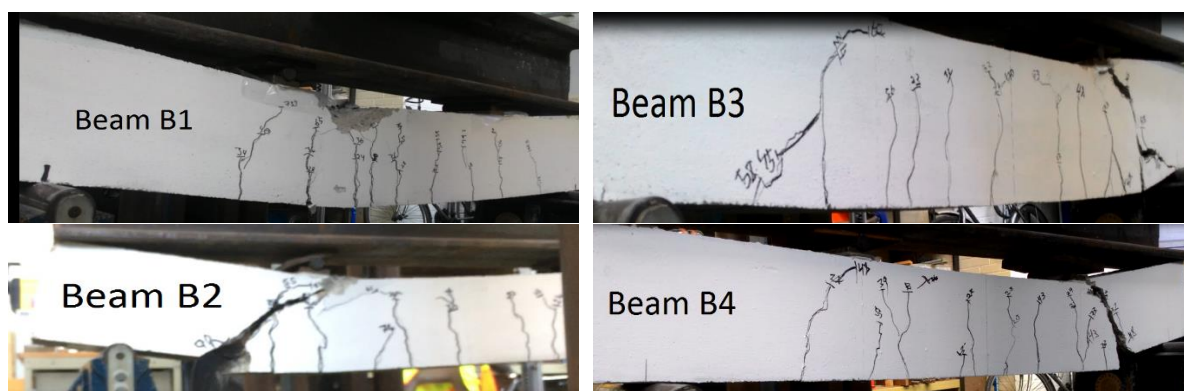
Flexural behaviour experiments revealed that crack propagation characteristics were similar for all four beams. Photo 6 shows that vertical cracks propagated in the middle region of the beams, followed by diagonal cracks located closer towards the supports. The first crack appeared during the application of an external load of 20 kN. More detailed crack propagation under increasing loading is illustrated in appendix **Error! Reference source not found.** The reinforced concrete beams' failure types are discussed in section 6.4.

Photo 6: Failure Modes of Each Beam.

Photo 6 also illustrates the failure mode of each beam. The observed failure modes suggest that the beam reinforced with 100% traditional steel reinforcement (Beam B1) failed in compression with concrete spalling from the top of the section which is the compression zone. On the other hand, the concrete beams reinforced with basalt longitudinal bars located at the bottom (Beams B2, B3 and B4) experienced failure which can be described as “shear failure”.

Ultimately, it is important to note that shear failure in BFRP rebar reinforced concrete beams occurred at one end only (refer to **Photo 6**). This could be caused by marginally different reinforcement position at each end of the beam. It is possible that reinforcement could have dislocated from its original position during the beam casting stage when a vibrating poker was used. In addition, that marginal difference in shear link spacing, during the reinforcement cage assembly phase could have contributed to the unsymmetrical reinforcement setup. Furthermore, the analysis carried out suggests, that the shear span of the tested beams was 1.8, as depicted in Figure 7. This suggests that the shear span ration was too low and potentially resulted in shear failure BFRP rebar reinforced beams as illustrated in Photo 6. Naik & Kute (2014) suggested that, that to prevent shear failure, shear span to depth ratio should be greater than 2.5.

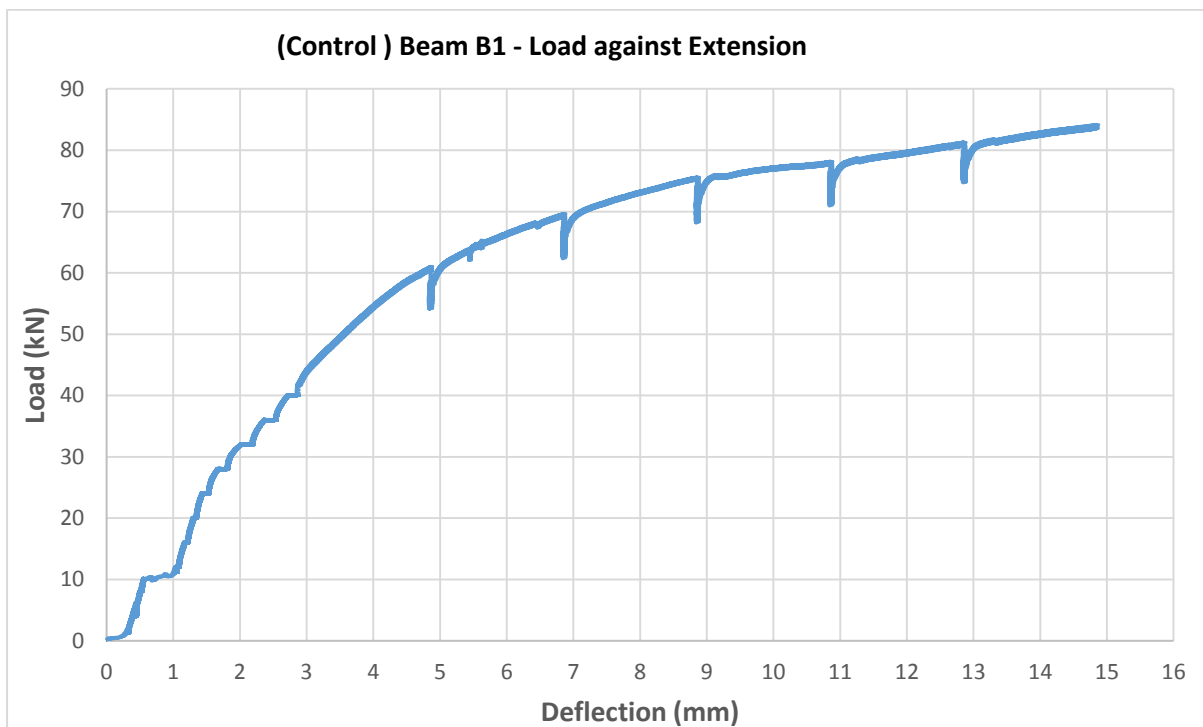
Firstly, the ultimate load capacity in kilo-Newtons (kN) was determined using ultimate load capacity principles calculated in appendix **Error! Reference source not found..** Subsequently, a flexure test of the reinforced concrete beam with 100% steel reinforcement was carried out. It is important to note that this beam was used as a control beam for comparison and analysis is outlined in further sections. The control beam flexure test showed that failure occurred at a maximum load of 84.13kN (including the self-weight of the transverse beam) with the corresponding deflection of 14.8mm as indicated in the Graph 2.

Graph 2: Beam B1: Load against Extension.

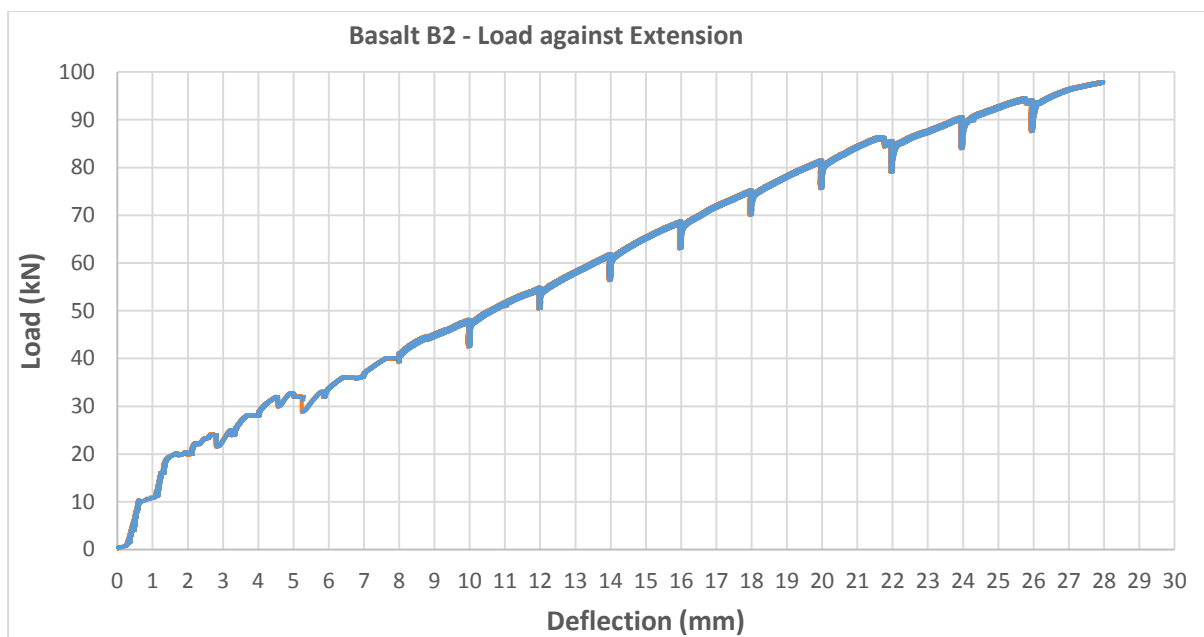
The results depicted in Graph 3 correspond to the flexure test of the reinforced concrete beam with basalt longitudinal bars located at the bottom (tension zone) and lapped with steel L bars at each end (refer to Figure 4). The maximum load achieved including the self-weight of the transverse beam was 97.9kN with a corresponding deflection of 27.927mm.

Graph 3: Beam B2: Load against Extension.

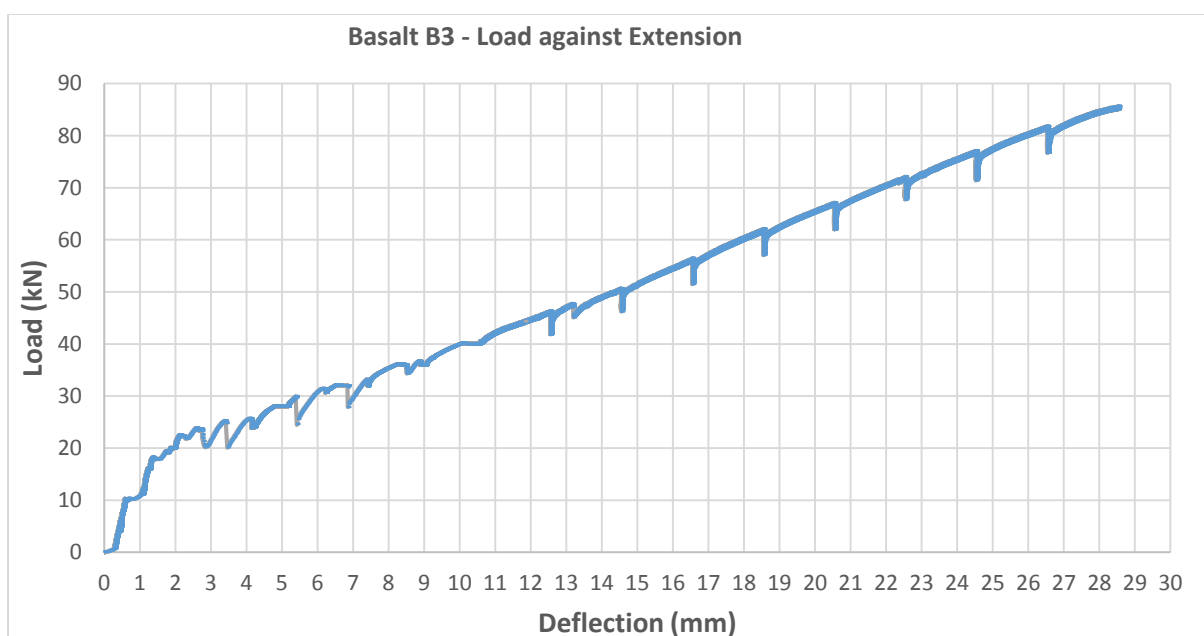
The experiment showed that beam 3 reached a maximum load of 85.642 kN (including the self-weight of transverse steel beam) with a corresponding deflection of 28.5mm. Graph 4 depicts B3 concrete beam's behaviour when subjected to load under flexure.

Graph 4: Beam B3: Load against Extension.

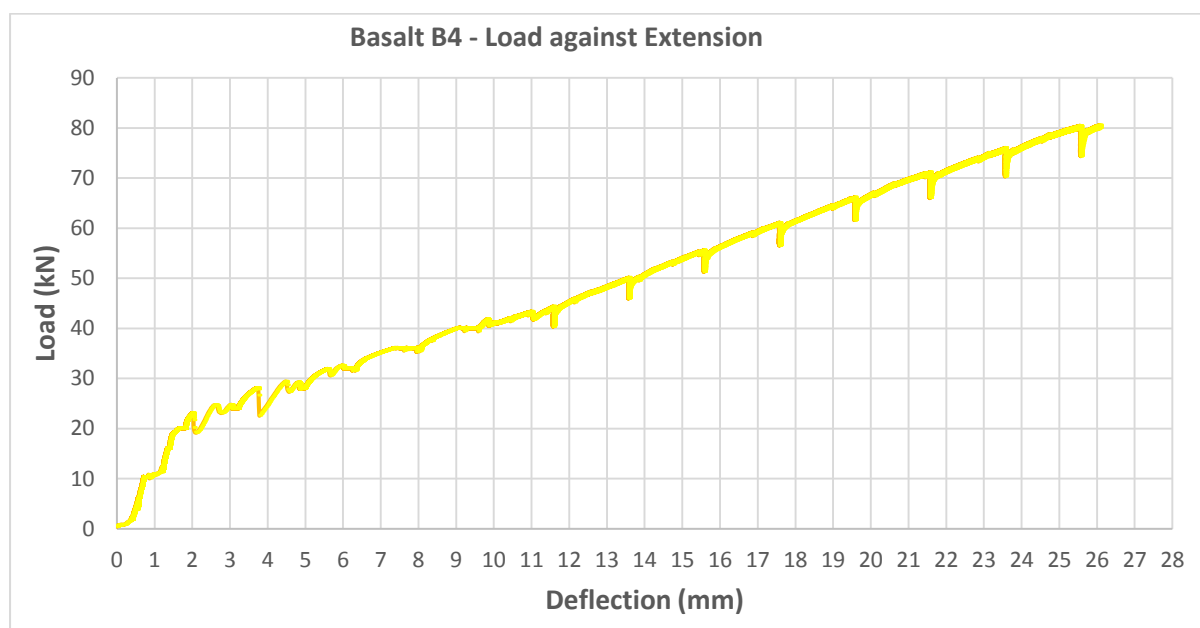
It was found that beam 4 reached a maximum load of 80.549kN (including the self-weight of the steel transverse beam) with a corresponding deflection of 26.1mm. Graph 5 depicts concrete beam B4's behaviour when subjected to load under flexure.

Graph 5:Beam B4: Load against Extension.

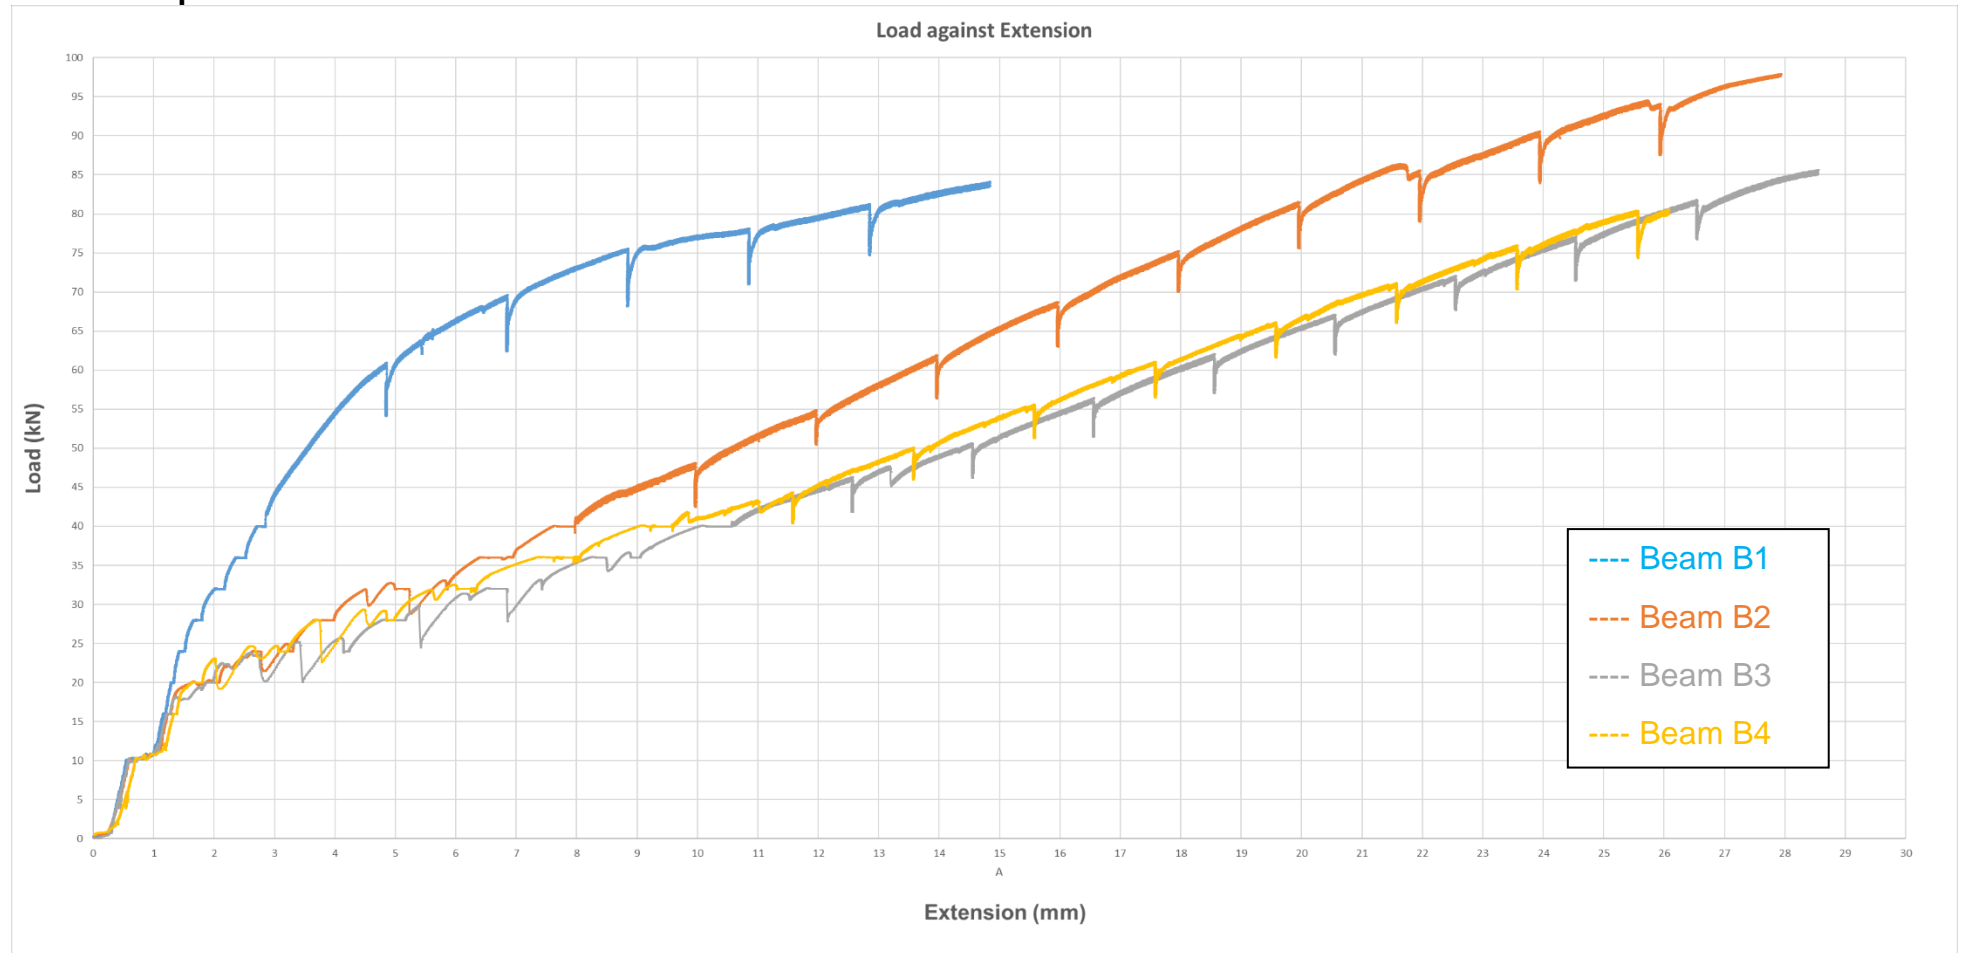
Furthermore, Graph 6 summarises the load and deflection relationship obtained by the reinforced concrete beam tests.

Graph 6:Comparison of All Four Beams: Load against Extension.

It is evident from Graph 6 that concrete beam concrete mix has been consistent since the initial gradient of load- deflection graphs up to around 20kN are almost identical. This suggests that the BFRP rebar reinforced un-cracked section concrete beams behaved virtually identical to traditional steel reinforced concrete beam when the section was un-cracked.

In contrast, it can be clearly seen that once the BFRP rebar reinforced beams are cracked, the behaviour in terms of load and displacement is fundamentally different. It appears from Graph 6 that the relationship between the cracked section load and displacement of the BFRP rebar reinforced concrete beams (B2, B3 and B4) is virtually linear, whereas the traditional steel reinforced concrete beam (B1) has a clearly visible yielding stage. This can be explained by the low value of BFRP rebar modulus of elasticity (refer to appendix **Error! Reference source not found.**), which is over 4 times lower than traditional steel rebar. Additionally, linear load and deflection relationship suggests that failure load should be easily predictable as opposed to the steel yielding stage.

Furthermore, there is a relatively small variation between the cracked section concrete beams reinforced with BFRP rebar as depicted in Graph 6. The ultimate load at which the beams failed varies from 5.9% to 21.5% within the 3 BFRP rebar reinforced concrete beams and the displacement variation ranges between 2.0% and 8.4%. Nevertheless, based on the previously outlined percentage variation, the suggestion can be made that a materials factor should be introduced when designing reinforced concrete beams reinforced with BFRP rebar to account for the ultimate load and displacement variations.

Moreover, Graph 6 shows that BFRP rebar reinforced concrete beam B3 with free ends (no anchor) exhibited greater maximum deflection at failure compared with the other two concrete beams which are BFRP rebar reinforced and lapped with steel L bars. Current experimental data obtained suggests that anchoring of BFRP tension rebar reduces maximum deflection. On the other hand, although beam B3 displayed the highest vertical displacement at failure, the corresponding failure load was higher than beam B4 but lower than beam B2. In order to support the hypothesis that anchoring BFRP tension rebar reduces the deflection, more samples beams must to be tested in order to provide more credible and robust results. In addition to that, beam B4 lower ultimate failure load being lower than beam B3 could be dictated by the BFRP tension bars being damaged by the steel L bars, observed during the visual inspection (refer to section 6.4.4).

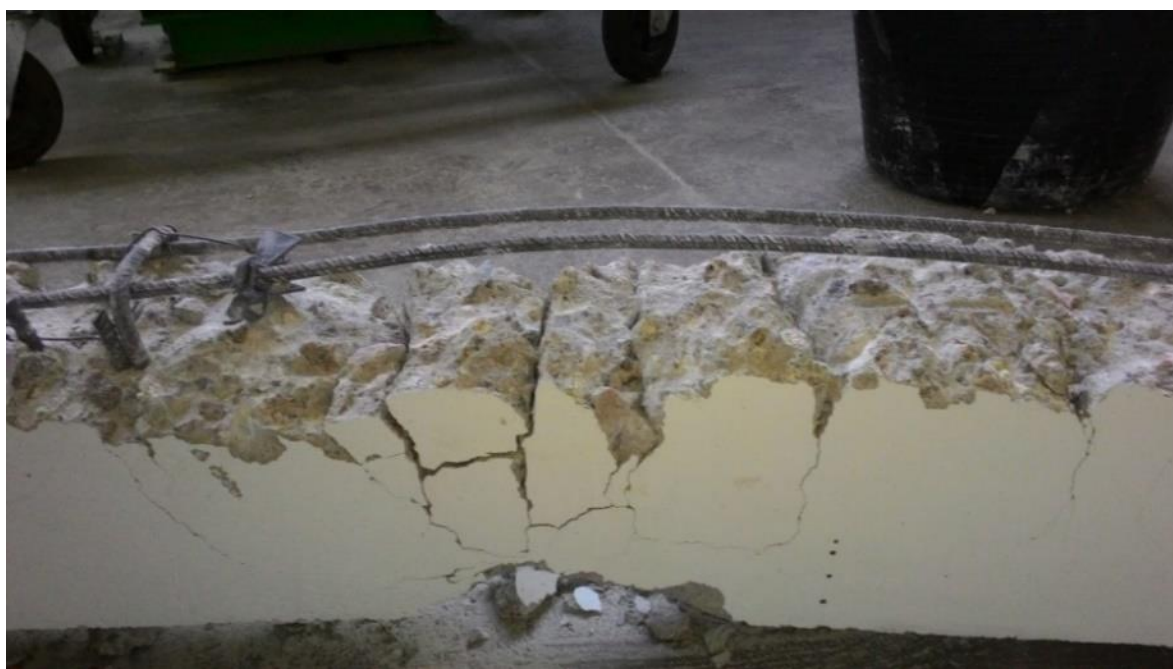
Concrete removal from the bottom face of the concrete beam reinforced using 100% steel reinforcement, showed that no significant slippage occurred. Further to that, bar yielding was clearly visible. Photo 7 illustrates the appearance of tension in the longitudinal steel rebar after undergoing a yielding stage.

Photo 7:Beam B1 Yielded Tension Steel Bars.

Beam bending tests showed that the concrete beam (B1) reinforced with 100% traditional steel reinforcement (refer to Figure 4), experienced compression failure as illustrated in Photo 6. This can be explained by the fact that once the concrete beam cracks, the neutral axis shifts higher towards the top of the concrete beam section. As this progresses further, the top area withstanding compression generated by the external load, reduces until the concrete’s compressive strength becomes lower than compressive force generated on to the beam by application of an external load. This causes concrete to spall from the top of the concrete beam and the beam to fail. Figure 6 depicts the compression area reduction in reinforced concrete beam. Furthermore, the compression failure (refer to Photo 6) occurred prior to steel bottom tension bar “snapping”. (refer to Photo 7).

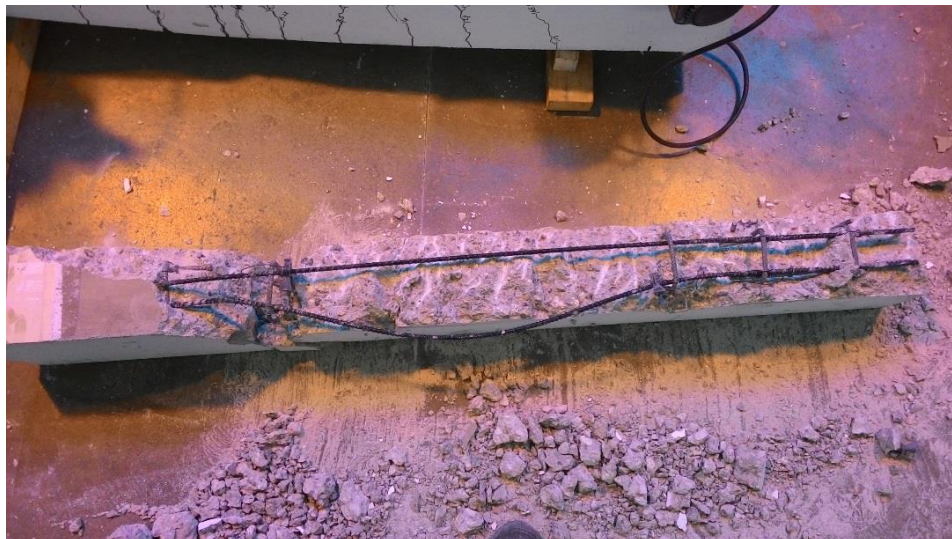
Further investigation revealed that one out of two longitudinal BFRP tension reinforcing bars “snapped”. However, the second rebar did not “snap”. Instead it went through significant elongation as illustrated in Photo 9 and Photo 11.

Photo 9:Bottom basalt rebar elongated.

It is important to address the fact that one of the basalt longitudinal bar underwent significant elongation only at the point of failure as depicted in Photo 9. It was initially assumed that the slippage of the BFRP rebar (located at the tension zone) occurred. The slippage phenomenon means that the BFRP rebar is moving irrespective of the concrete surrounding the rebar. However, subsequent full exposure of bottom basalt longitudinal bars showed that slippage did not occur that could be detected by a visual inspection, as there was no evidence of rebar slipping. This suggests that once the first basalt bottom longitudinal bar “snapped” full load applied by the experimental machinery was transferred onto the second basalt bottom rebar. At this point rebar was carrying the load which was twice the load the rebar was designed to carry. This dramatic elongation can be explained by the high Poisson’s ratio. It was established by Gohnert, Gool & Benjamin (2014) that Poisson’s ratio is approximately 4 (subject to variation depending on manufacturer) as opposed to steel with ratio of 0.25-0.3. This means that basalt reinforcement can go through significant elongation which results in reduction of the cross-sectional area compared to traditional steel reinforcing rebar.

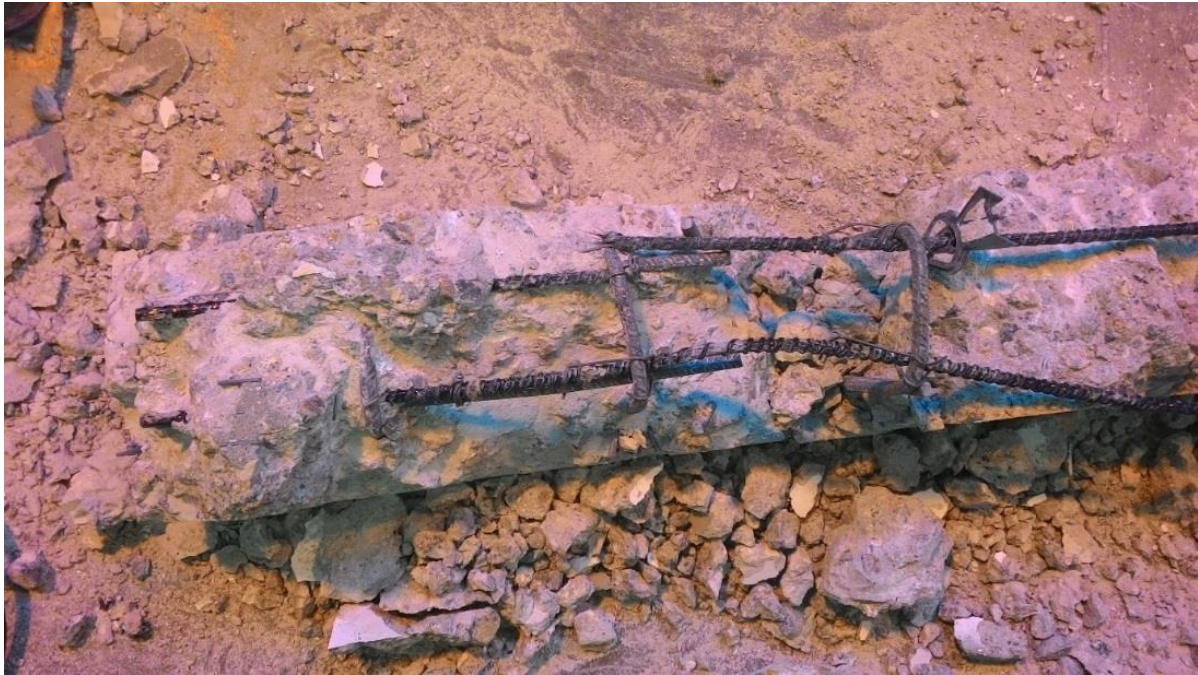
Finally, full concrete removal from the bottom face showed that no significant slippage occurred, that could be detected by visual inspection, as illustrated in Photo 10.

Photo 10:Basalt B2: bottom face of the beam.

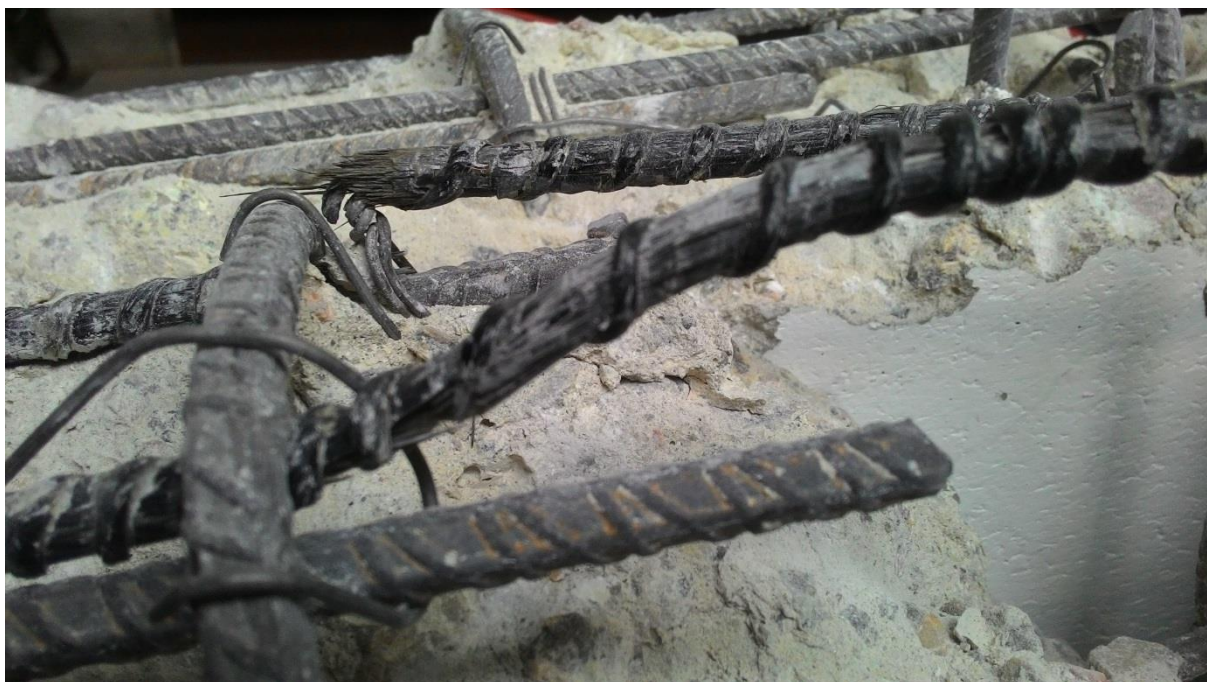
Photo 11:BFRP Rebar Reinforced Concrete Beam B2: Reinforcement Failure.

Furthermore, it is evident from Photo 11 that the failure of the BFRP rebar occurred at the conjunction with the steel shear links. This suggests that steel shear links could have caused the failure of BFRP rebar. Based on the evidence currently available, it seems fair to suggest that steel shear links were forced to move up when the concrete beam was subjected to an external load and therefore exhibited deflection by curvature. This could have caused local stresses to concentrate onto the BFRP longitudinal rebar at the junction with the steel shear links.

In addition to that, Photo 11 depicts that the second bottom longitudinal BFRP rebar was not far from its breaking point. It can be seen in Photo 11 that the BFRP rebar that underwent significant elongation, started to break at the location very close to the shear link. Also, it is visible from Photo 11 that the BFRP rebar fibres are starting to break. Additionally, it is visible that resin which bonds the basalt fibres in the rebar changed colour, which indicated the failure of the resin.

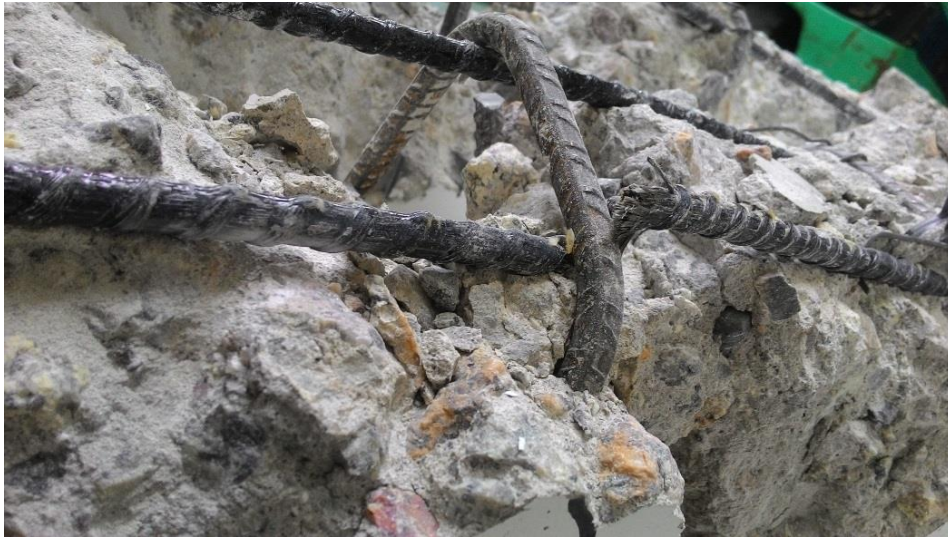
The same procedure of visual inspection was carried out for basalt beam B3 and it was observed that one bottom bar “snapped” at the conjunction with the steel shear link as illustrated in Photo 12.

Photo 12:Beam B3 Reinforcement Failure.

Similar results were observed when BFRP rebar reinforcement was exposed. Photo 12 shows that only one BFRP tension rebar “snapped”. BFRP rebar failure occurred at the conjunction with the steel shear link, suggesting the failure was caused by the steel shear link.

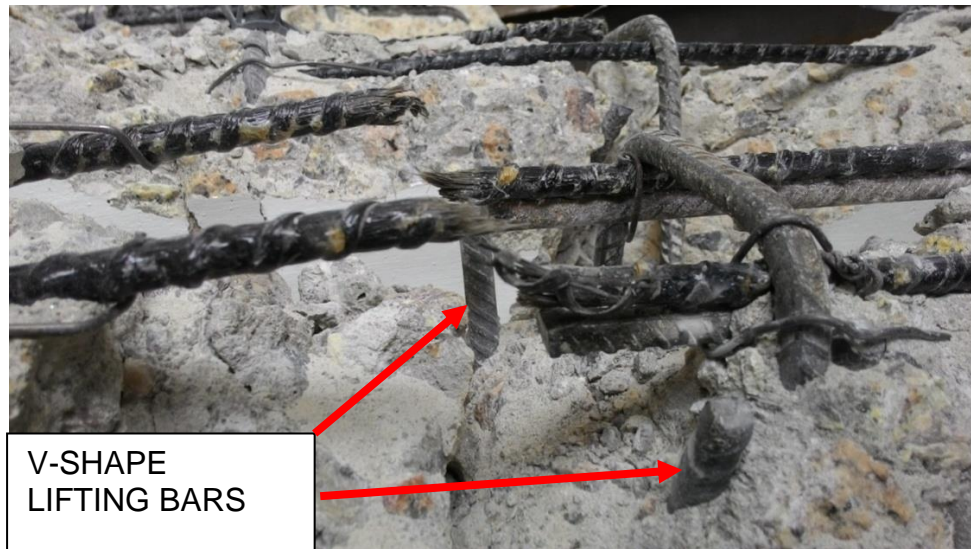
Visual inspection showed that the both BFRP tension bars “snapped” in beam B4. Failure of the basalt beams occurred at the “shear crack” propagation point. The failed basalt bars did not exhibit significant elongation before failure as opposed to beam 2 as outlined in section 4.3.

Photo 13:Beam B4 Reinforcement Failure.

During the visual inspection of the beam B4 (refer to section 5.4) it was observed that both BFRP tension bars “snapped”. Interestingly the basalt bars failed at the exact location where the steel L bars end when lapped with BFRP tension bars (refer to Photo 13). This suggests that during the period when beam was subjected to external load the concrete beam curvature increased forcing the steel L bars down, resulting in steel L bars contributing to failure of BFRP longitudinal bars by causing localised stresses. Further to that, bending moment and shear capacity checks outlined in appendix **Error! Reference source not found.** suggest that concrete beam B4 was more than capable to withstand the forces applied at the point of failure. The analysis undertaken at the location of the failure showed, that area of tension reinforcement required to withstand the subjected forces was 68mm^2 . Two 8mm diameter BFRP bars provided 101mm^2 area of reinforcement. This signifies that reinforcement failure at the location of concrete beam failure was not caused by bending. Furthermore, shear check outlined in appendix **Error! Reference source not found.** also suggests that failure was not caused by the failing shear links. Shear force applied required minimum of 30mm^2 , whereas steel shear links used provided area of 151mm^2 . The area of reinforcement that the shear links provided was over three times more than required.

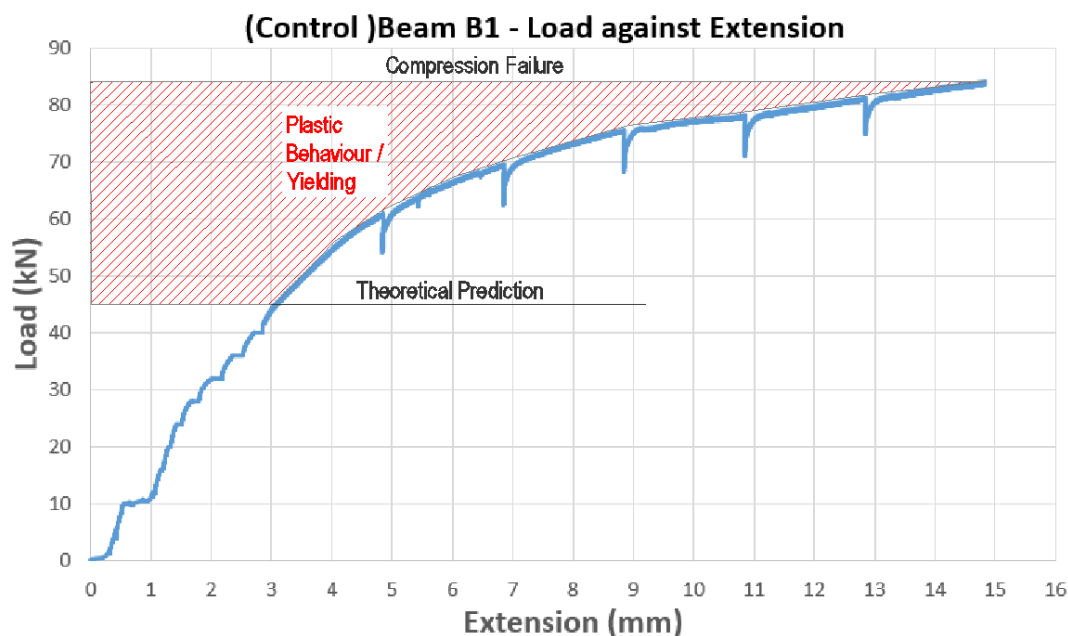
Failure load summary in Table 1 shows significant difference between beam B1 theoretical and experimental failure load values. Traditional steel reinforcement design principles outlined in the appendix **Error! Reference source not found.** calculates the failure load up to the plastic limit when steel bars start to yield. This explains the experimental failure load being over 46% higher than predicted. When tension bar reinforcement reached plastic behaviour, it was still able to accommodate increase in load by the means of yielding (refer to Figure 5).

Figure 5: Steel Bar Yielding.
